# Manhole Inspection Summary

Manhole # S15C\_\_031MH

Insp Date: **8/3/09 11:34 AM**

**Location** Address: **2710 FRANKLIN ST**

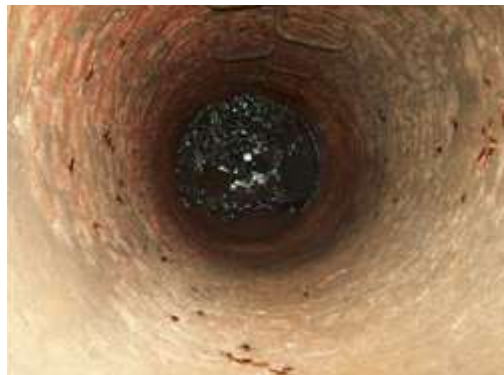
Top View

**Active Surge - 3 Attempts - Surcharged Conditions  
Verified through CCTV - Need Specialty Cleaning**
